Restoring the midline single tooth fracture in fluorosis case in the easiest way

Abstract

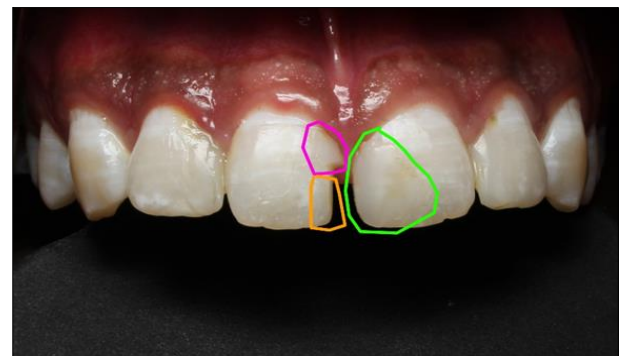
Fig 1

- Tooth No. 11: The remaining old composite is marked in pink. There is undermined dentin after the fracture, marked in orange.
- Tooth No. 21: The old restoration with demarcated margins between the restoration and dentin is visible. Pre-planning with editing software involved marking the midline and occlusal line, and drawing the approximate outline to recreate the tooth. This preparation set the stage for the procedure.

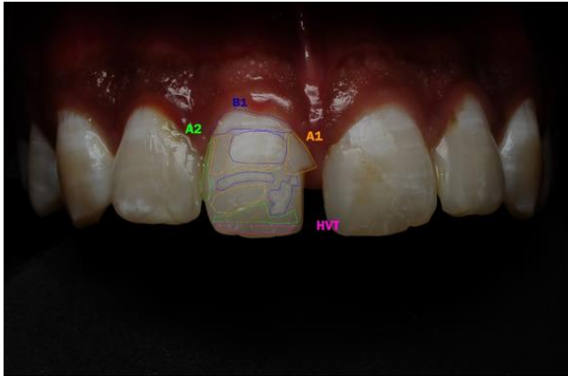
Fig 2

- Shade B1 is marked in blue
- Shade A1 is marked in orange
- Shade A2 is marked in green
- High-value translucent shade is marked in pink

These shades need to be matched during the composite layering process.

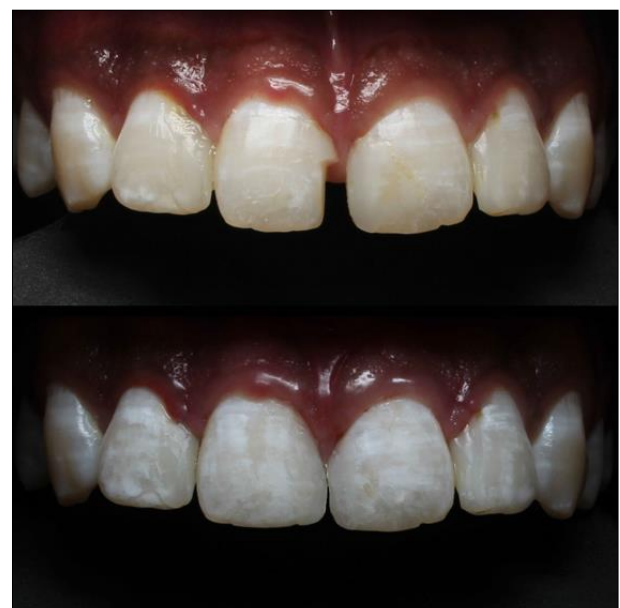
Fig 5: Before and after image of the procedure

- Assessment of the restored teeth for proper shade matching and integration with the surrounding teeth. Post pre-polishing and polishing with both teeth 11 and 21. The beautiful merging of layers can be appreciated, mimicking the fluorosis and its patches.
- Comparison of before and after images to evaluate the success of the restoration.
